SUBJECT: Dual Motor Electric PV 00002-534-13 & Polyhawk 00002-560-07

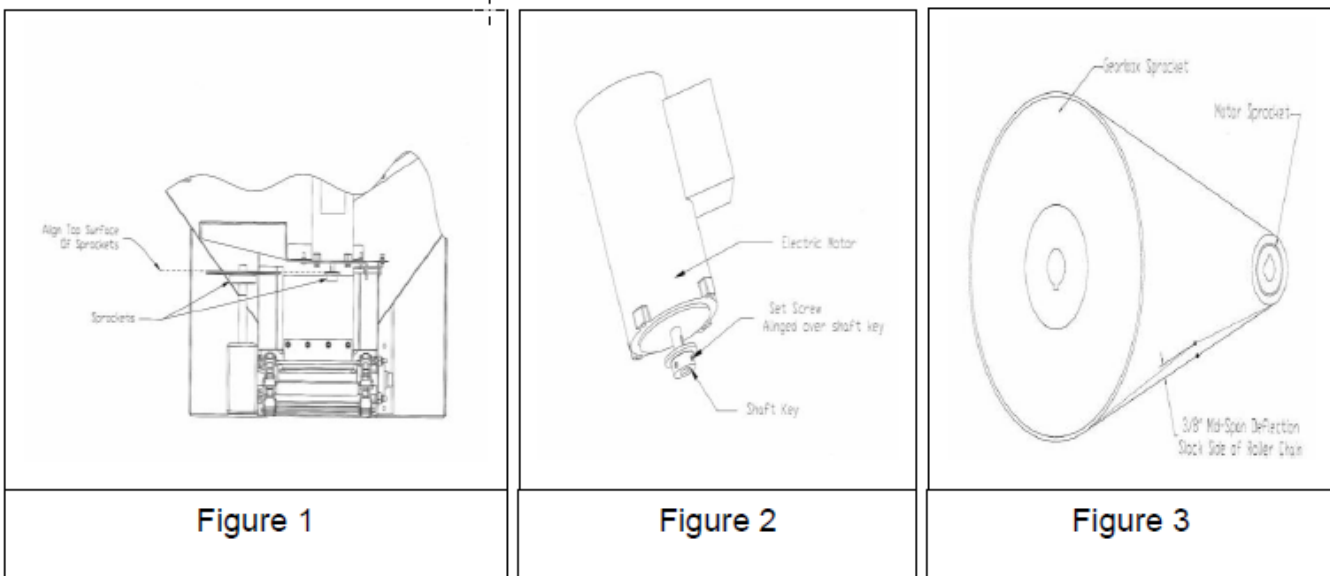
Swenson has learned the drive sprockets on the gearbox and conveyor electric motor may be misaligned which could possibly cause damage to the electric motor shaft. Units with serial numbers 0411-XXXX and newer, or units shipped after 5/1/2011 are not affected by this service bulletin. Please inspect and repair any spreaders in your inventory and submit a warranty claim. Swenson will reimburse for .5 labor hours per unit to perform this repair.

1. Gearbox and conveyor drive motor sprockets are aligned horizontally (see figure 1 below).
2. Shaft keys are aligned with sprockets and set screws are properly tightened (see figure 2 below).
3. Roller chain between conveyor drive motor and gearbox is tensioned to allow for 3/8" deflection midway between sprockets on the slack side of roller chain (see figure 3 below).
