SUBJECT: Dual Motor Electric PV 00002-534-13 & Polyhawk 00002-560-07

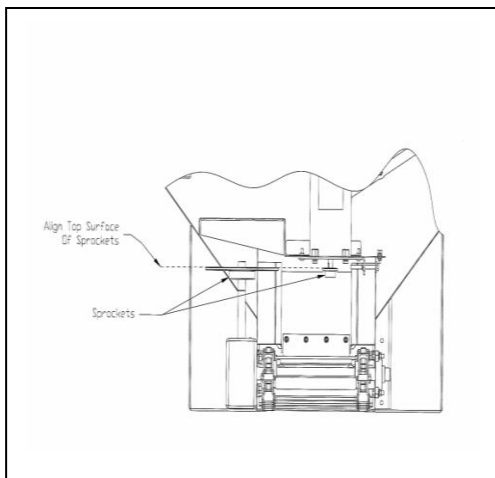
Figure 1

Swenson has learned the drive sprockets on the gearbox and conveyor electric motor may be misaligned which could possibly cause damage to the electric motor shaft. Units with serial numbers 0411-XXXX and newer, or units shipped after 5/1/2011 are not affected by this service bulletin. Please inspect and repair any spreaders in your inventory and submit a warranty claim. Swenson will reimburse for .5 labor hours per unit to perform this repair.

1. Gearbox and conveyor drive motor sprockets are aligned horizontally (see figure 1 below).
2. Shaft keys are aligned with sprockets and set screws are properly tightened (see figure 2 below).
3. Roller chain between conveyor drive motor and gearbox is tensioned to allow for 3/8" deflection midway between sprockets on the slack side of roller chain (see figure 3 below).
